Experimental Study MR 97-04

**Evaluation of Dowel Bar Retrofit  
Using Minnesota Specified 3U18 Patch Mix**

**Final Report**

Project IM-8-029(006)000

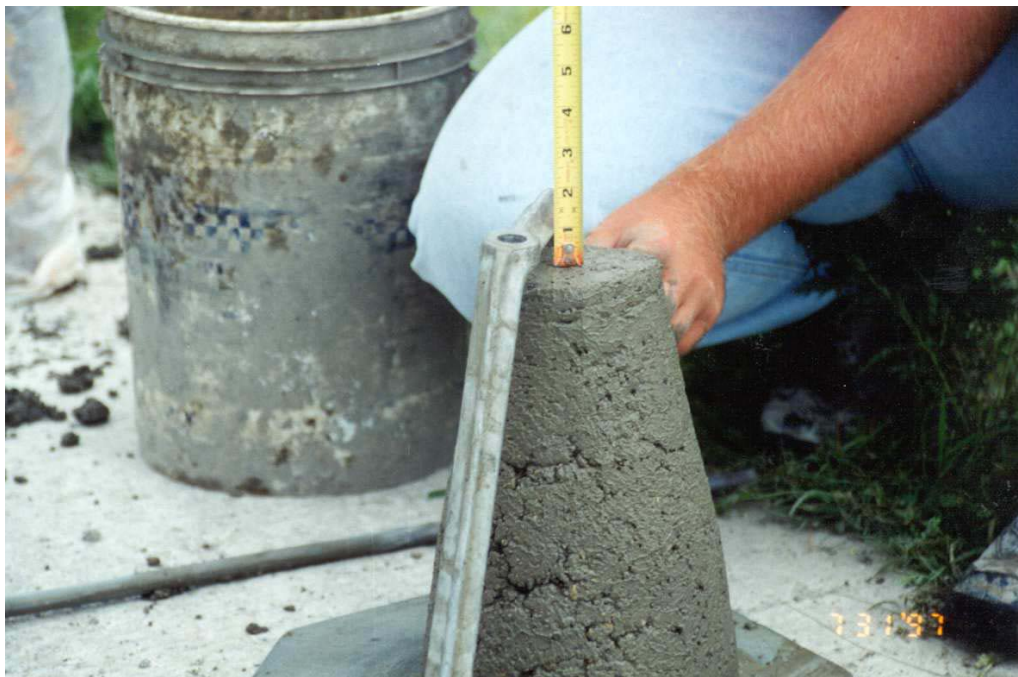
Photo 8 indicates the final slump was 3/4". The contractor commented that 3/4" or less was desired for this type of mix to aid in reducing shrinkage in the mix. Water reducers/accelerators were added to improve workability.

**Photo 8 - View of a slump test being performed on the 3U18 mix.**

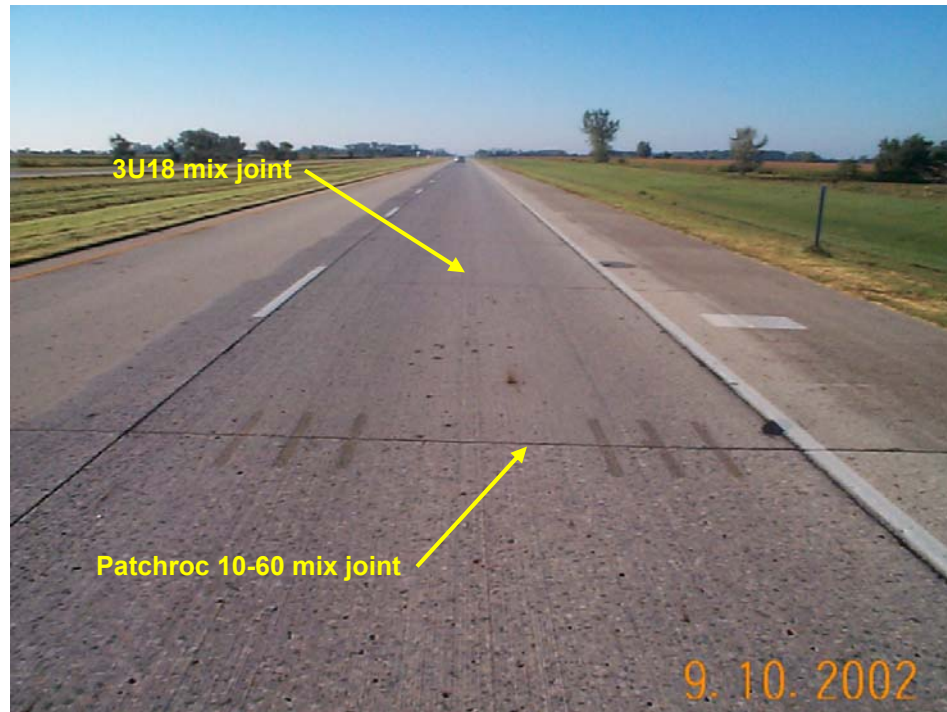
**Photo 13 - Overview of dowel bar slots, 1<sup>st</sup> joint contains Patchroc 10-60.**

Overall the 3U18 patch mix looked good with some visible cracks appearing at the surface. The cracks do not appear to be affecting the performance of the mix. Shrinkage cracks were detected within three months after placement of 3U18 patch mix in the 1995 test section that had affected the performance.

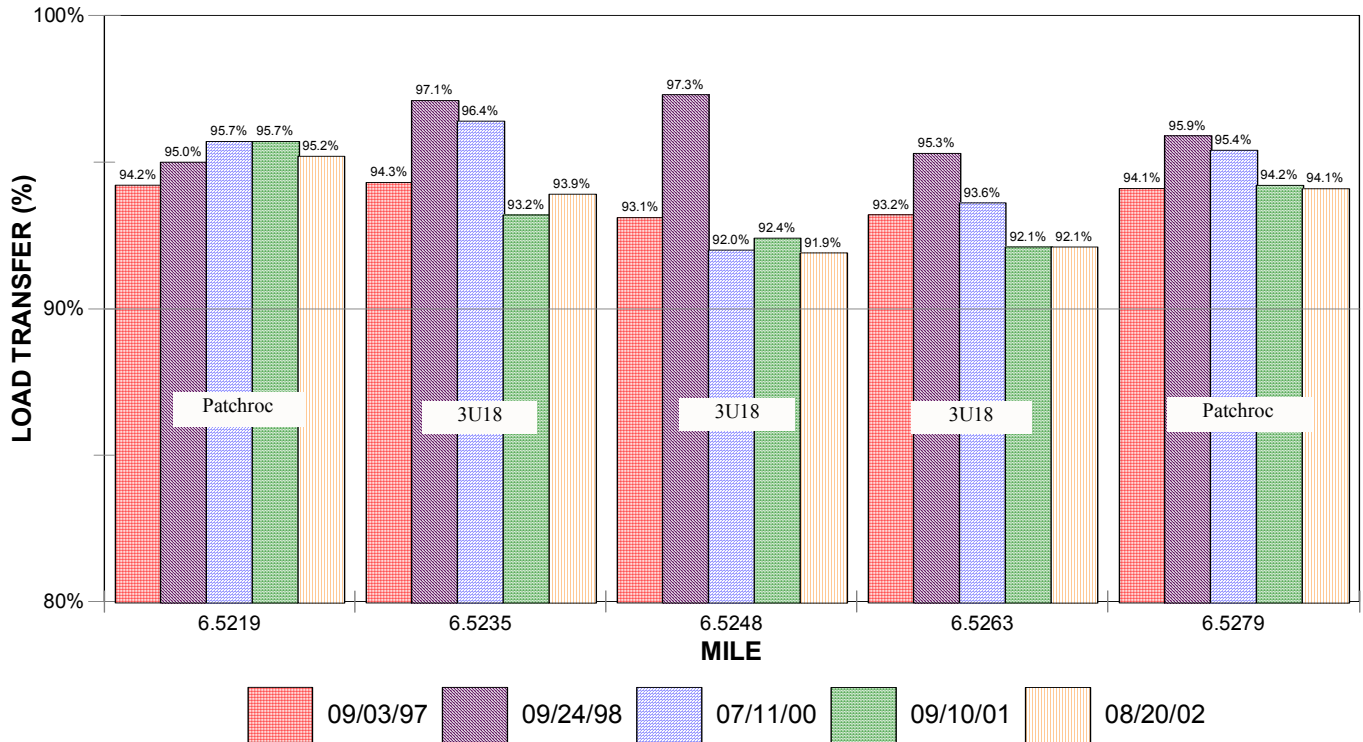
FWD analysis shows the 3U18 mix has an average load transfer efficiency of 92.6% while the Patchroc 10-60 mix has 94.7% load transfer efficiency after five years. Refer to the chart on the next page for the load transfer efficiency numbers.

The 3U18 mix has some hairline cracks between the existing concrete and the patch mix in some of the dowel bar slots. These cracks do not appear to be affecting the load transfer efficiency as dictated by an average load transfer of 92.6%. The other distress that is occurring in the 3U18 mix is minor aggregate popouts. The surrounding pavement also has popouts.

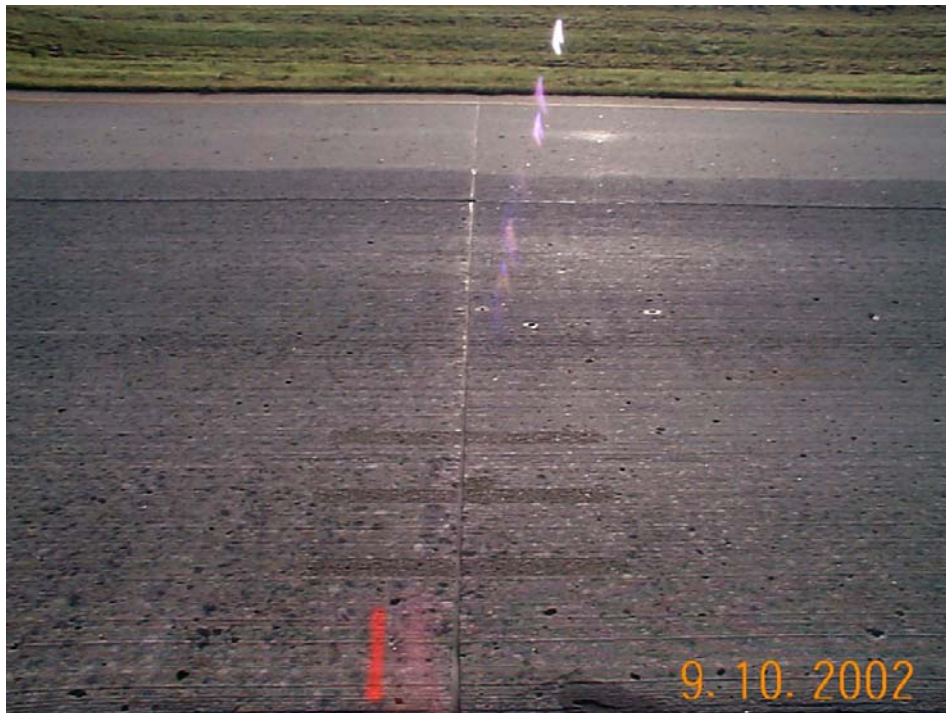
One very noticeable difference between the 3U18 mix and the Patchroc 10-60 mix is the aesthetics of the mix. Photo 13 shows one the Patchroc joints and then the 3U18 mix joints. The 3U18 mix joints are virtually undetectable. Photos 14, 15, and 16 shows the joints with the different patch mix materials.

**Photo 14 - Dowel bar slots containing Patchroc 10-60.**

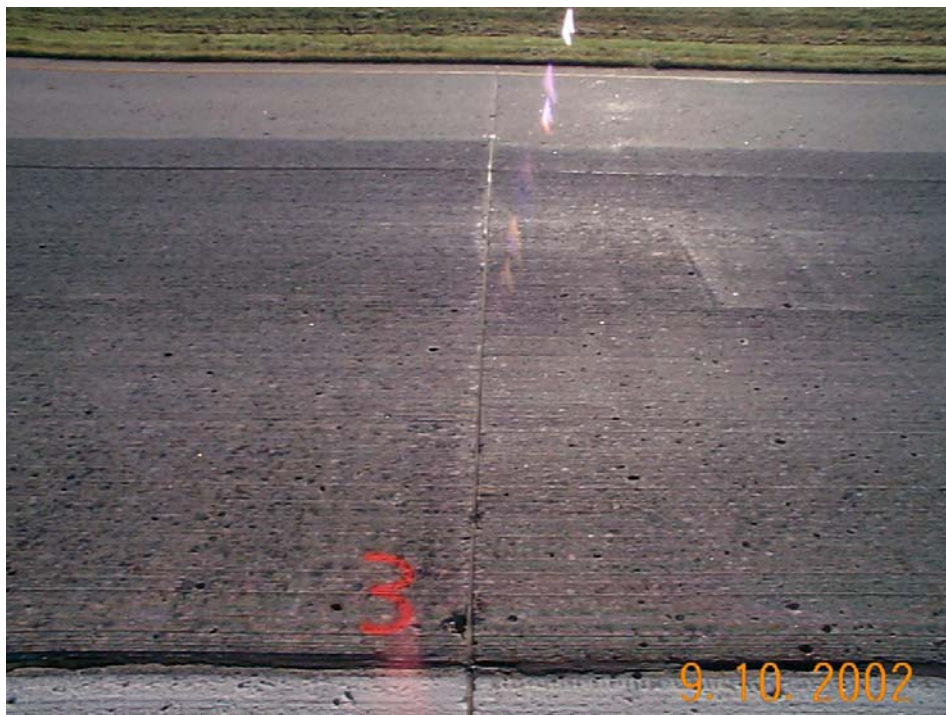
**Photo 15 - Dowel bar slots containing 3U18.**

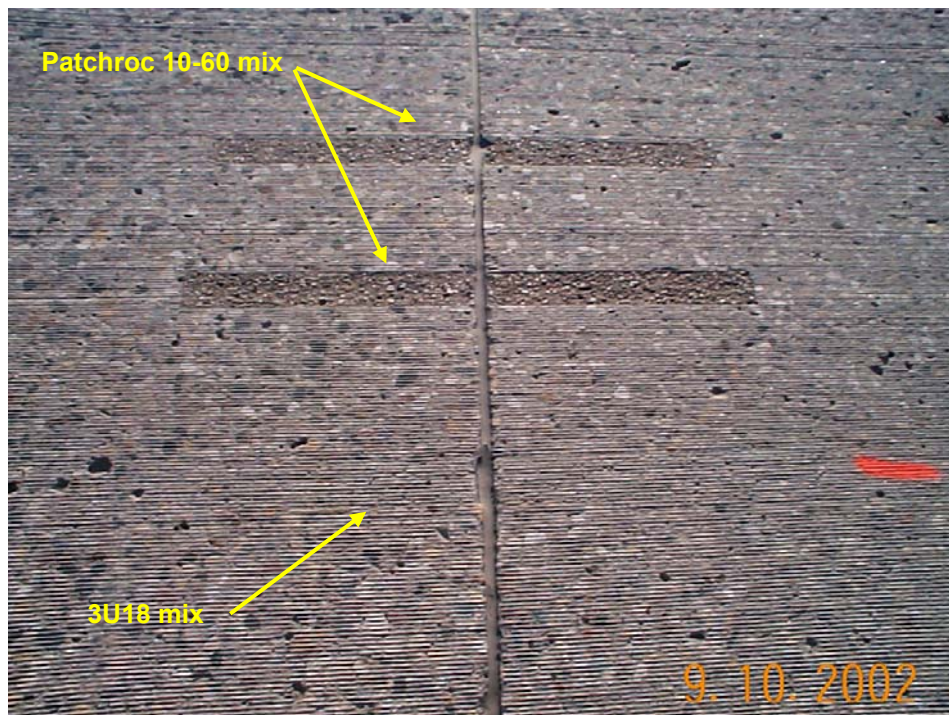
**Photo 16 - Comparison of the mixes side by side.**

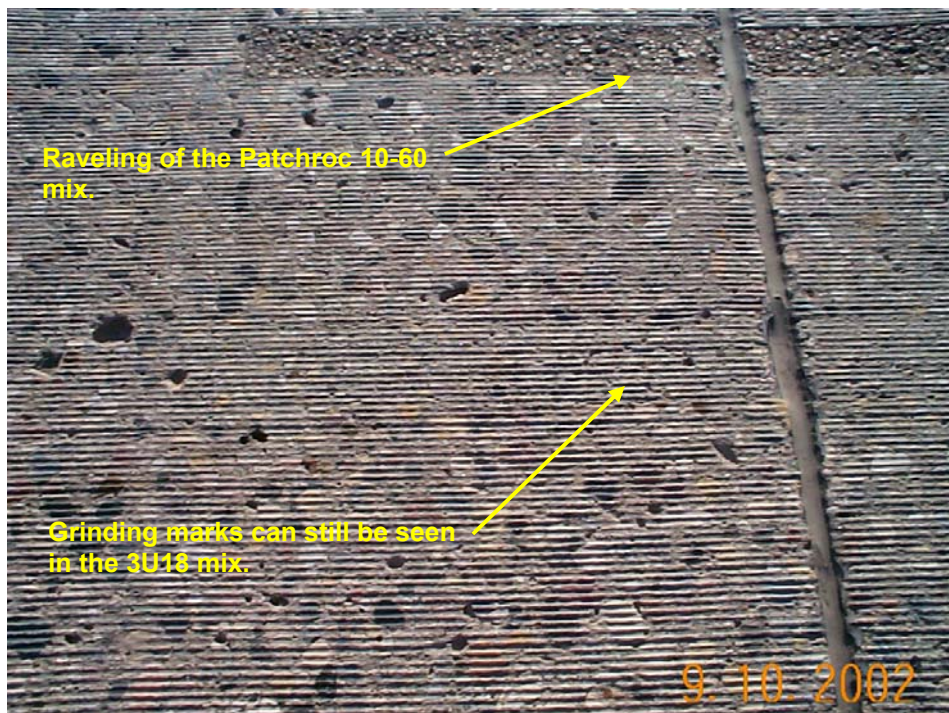
The durability of the 3U18 mix also appears to be better than the Patchroc 10-60 mix. Refer to photo 17.

**Photo 17 - Durability of both mixes.**

As can be seen in photo 17, the Patchroc 10-60 is raveling at the surface while the grinding marks can still be seen in the 3U18 mix.

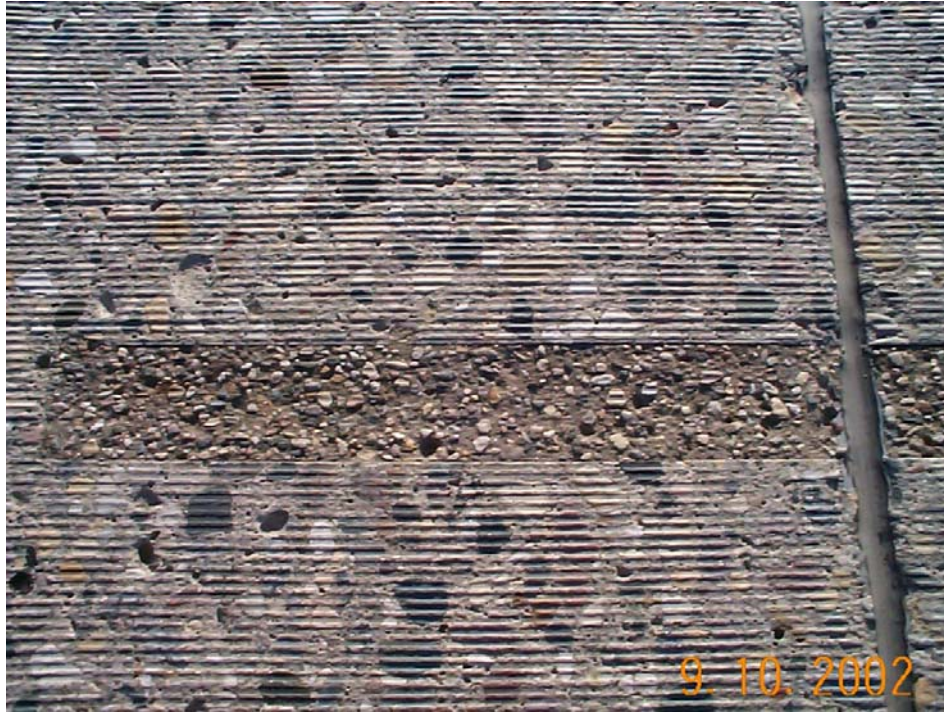
**Photo 18 - Close up view of the Patchroc 10-60 mix shown in photo 17.**
